Historic Resources Report

**3935 Thacher Road
Ojai, California, County of Ventura**

**Pamela Post, Ph.D., Senior Author and Tim Hazeltine
Post/Hazeltine Associates
213 A West Anapamu Street
Santa Barbara, CA 93101
Phone: (805) 682-5751
email: posthazeltine@cox.net**

February 18, 2025

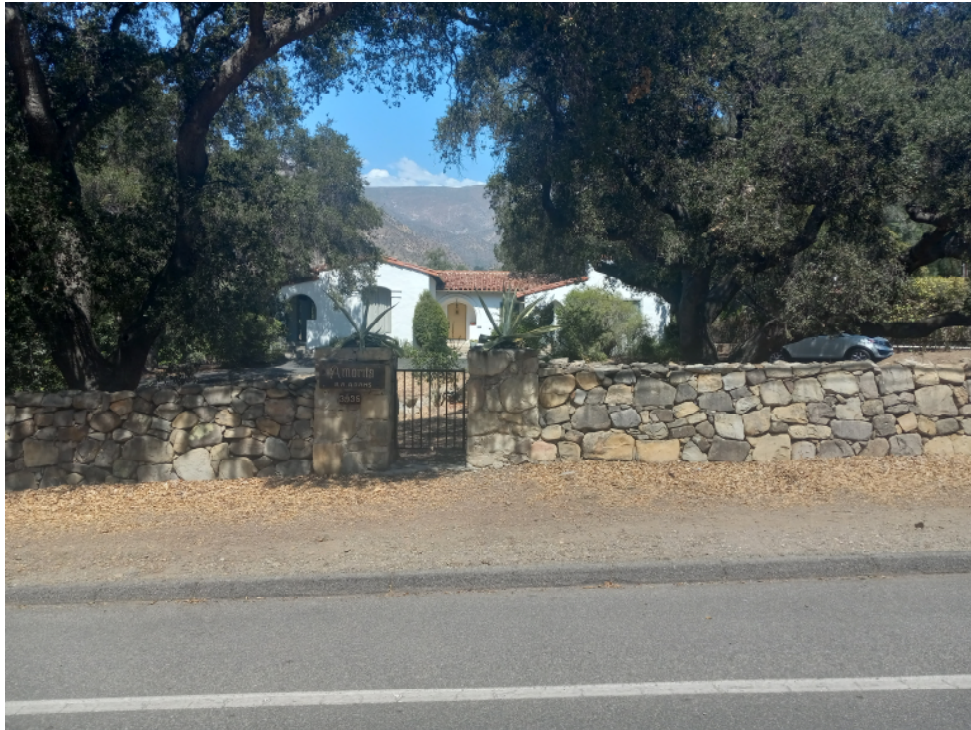
**Photograph #7 Property at 3935 Thacher Road
South elevation of house (Looking north)**

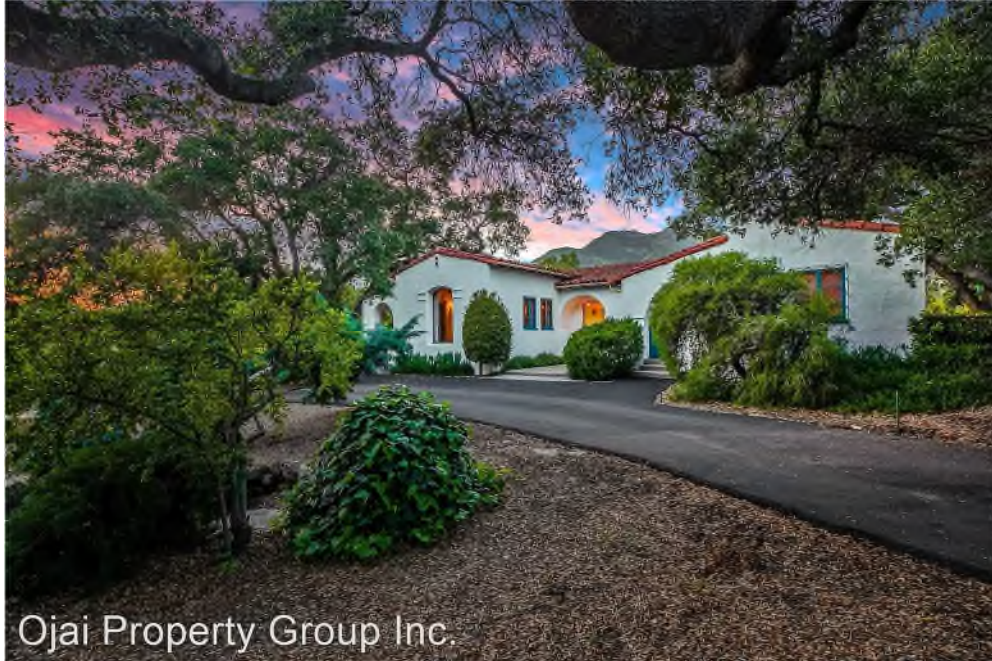
**Photograph #8 Property at 3935 Thacher Road
South elevation of house (Looking NW)
(Photograph courtesy of Ojai Property Group Inc.)**

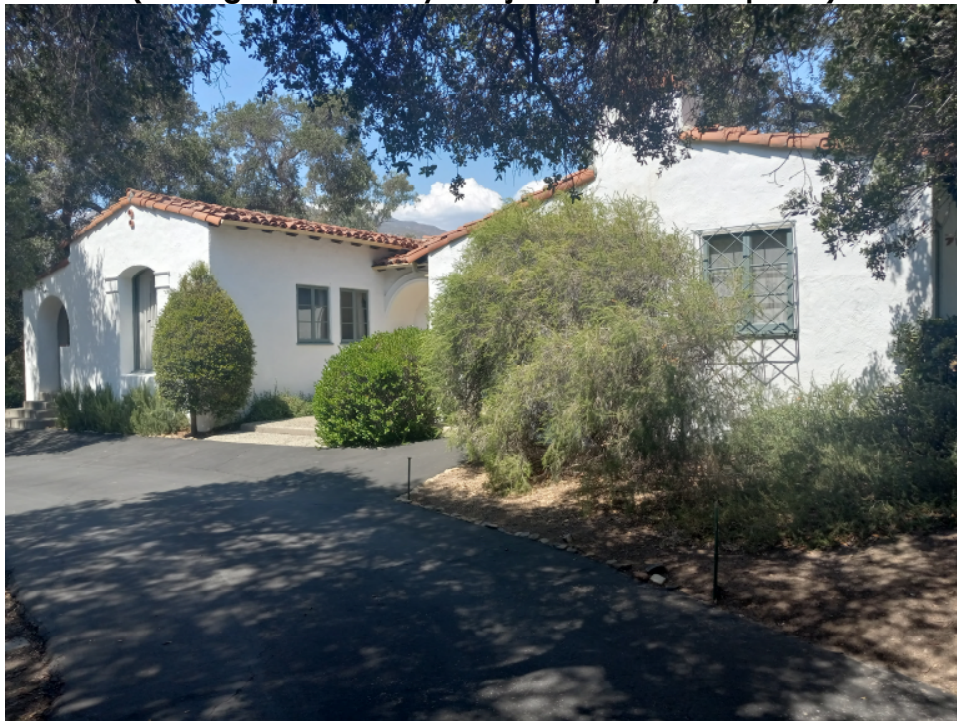
**Photograph #9 Property at 3935 Thacher Road
South elevation of house (Looking NW)**

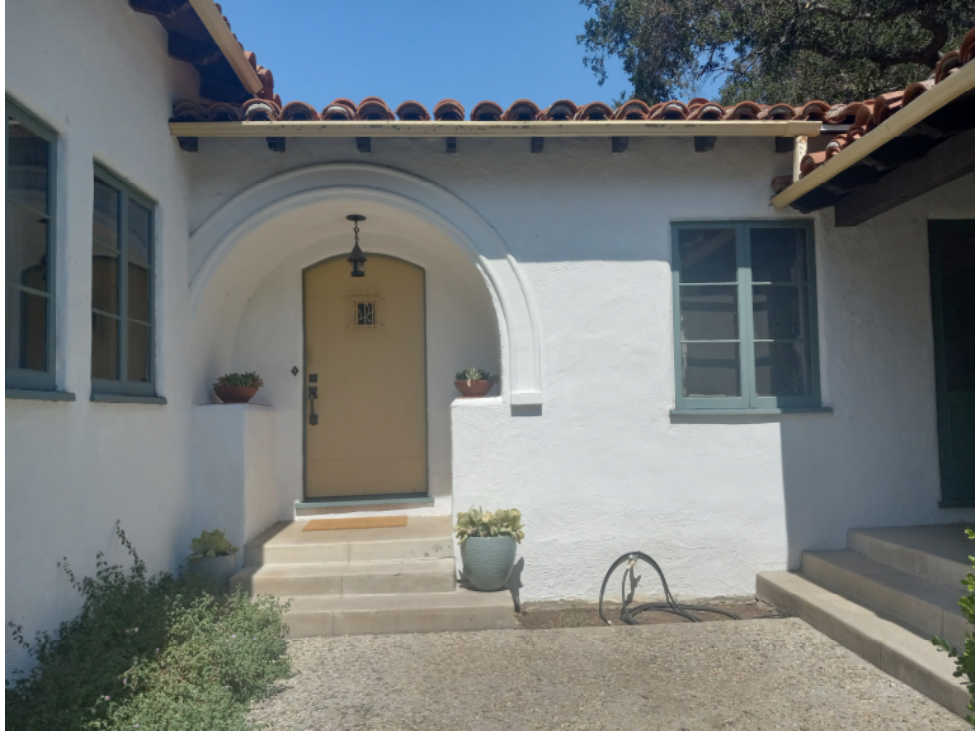
**Photograph #10 Property at 3935 Thacher Road
South elevation of house (Looking north)**

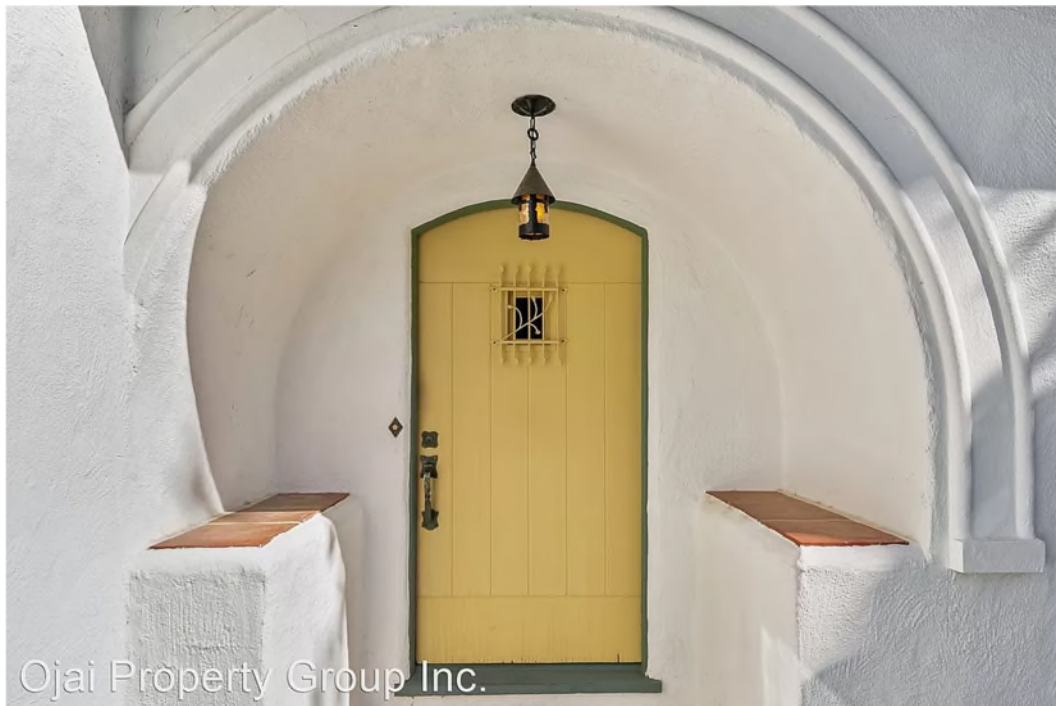
**Photograph #11 Property at 3935 Thacher Road
South elevation, detail of entry door (Looking north)
(Photograph courtesy of Ojai Property Group Inc.)**

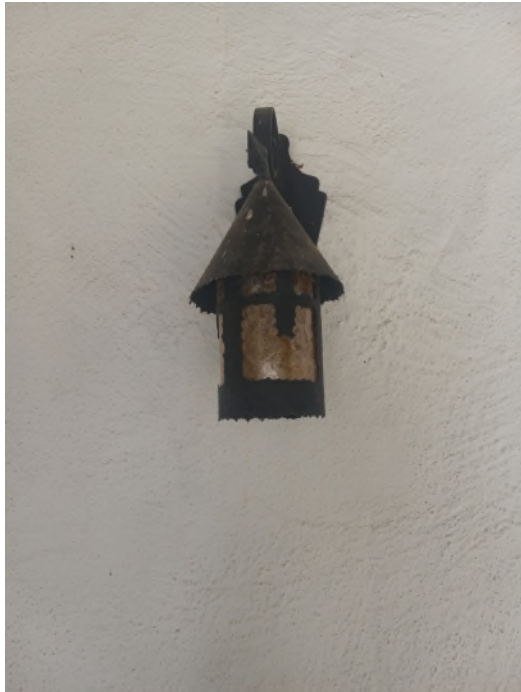
**Photograph #12 Property at 3935 Thacher Road
South elevation, detail of light fixture**

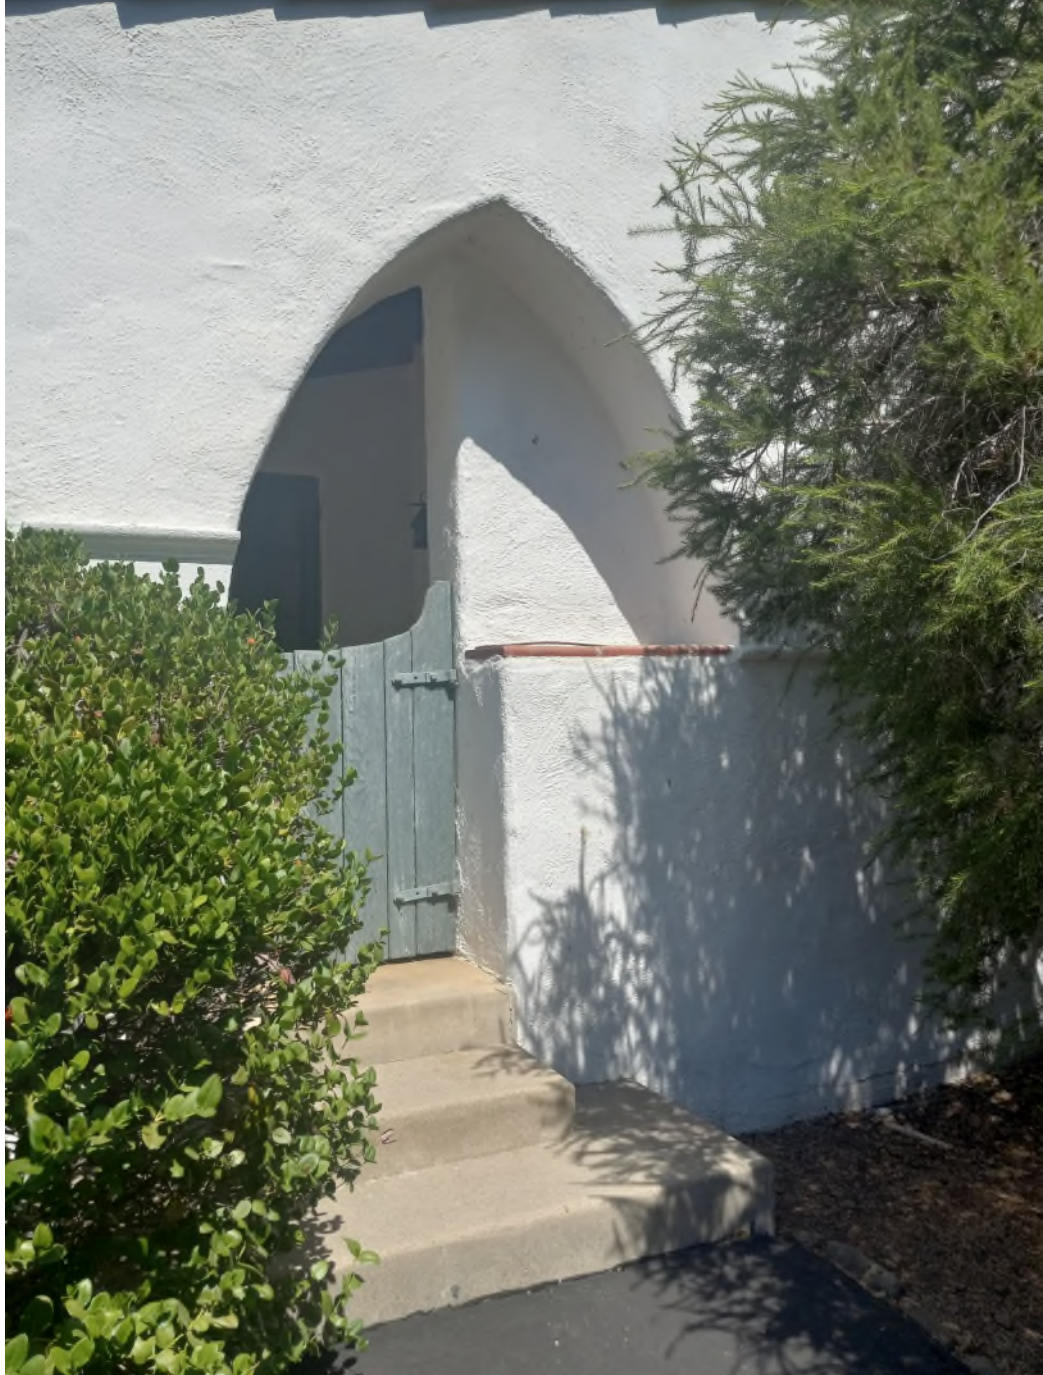
**Photograph #13 Property at 3935 Thacher Road
South elevation, detail of arched doorway**

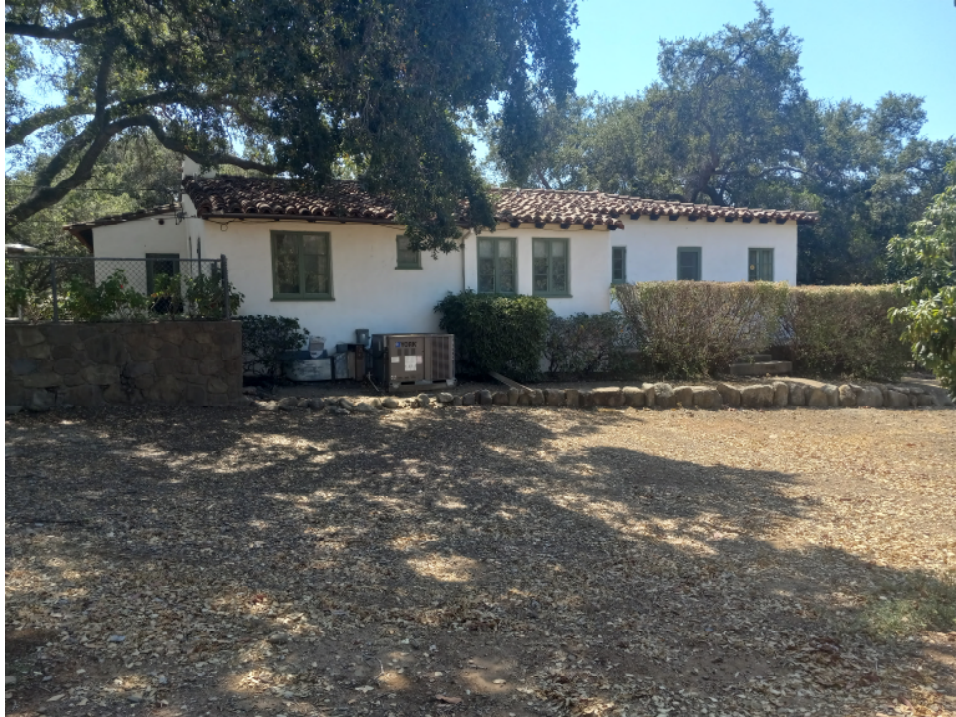
**Photograph #14 Property at 3935 Thacher Road
North elevation (Looking south)**

North Elevation (See Photographs #14 & 15)

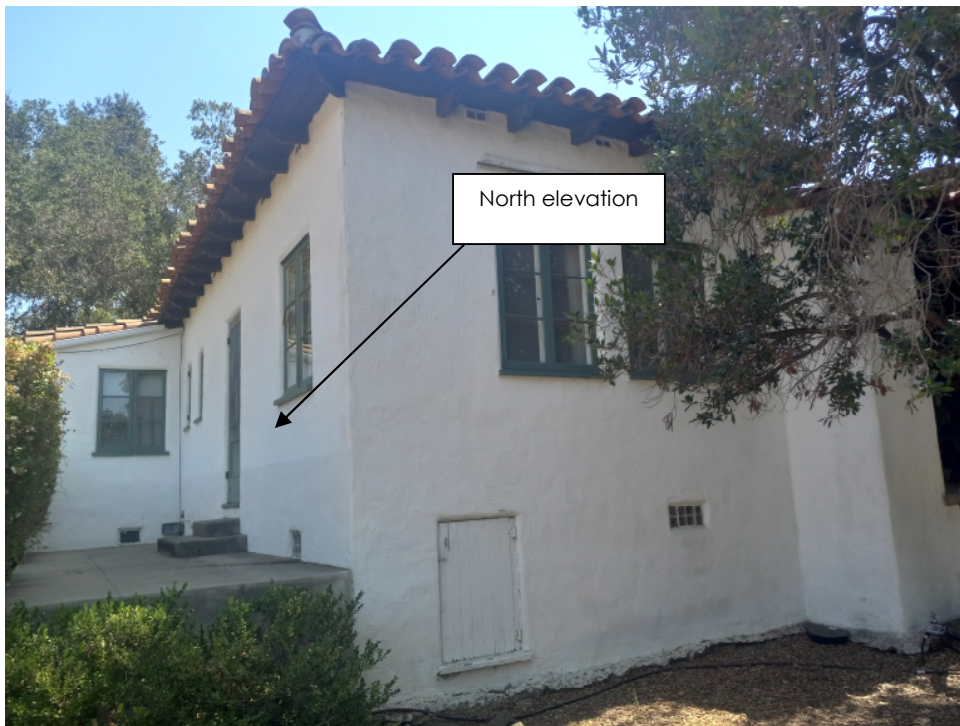
**Photograph #15 Property at 3935 Thacher Road
West of north elevation (Looking east)**

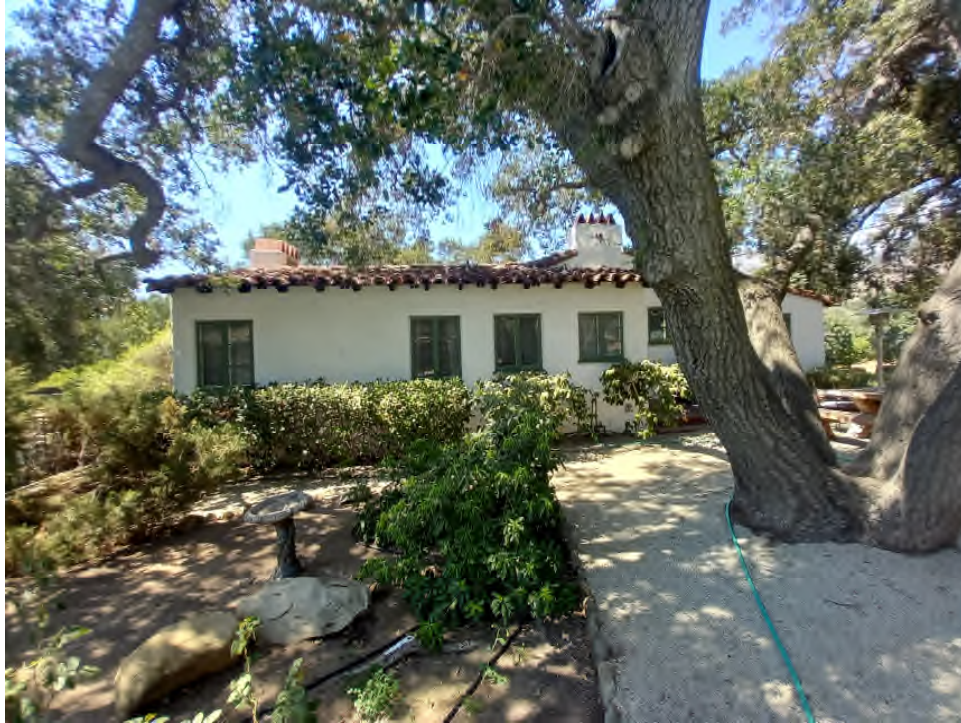
**Photograph #16 Property at 3935 Thacher Road
South end of east elevation (Looking west)**

East Elevation (See Photographs #16 & 17)

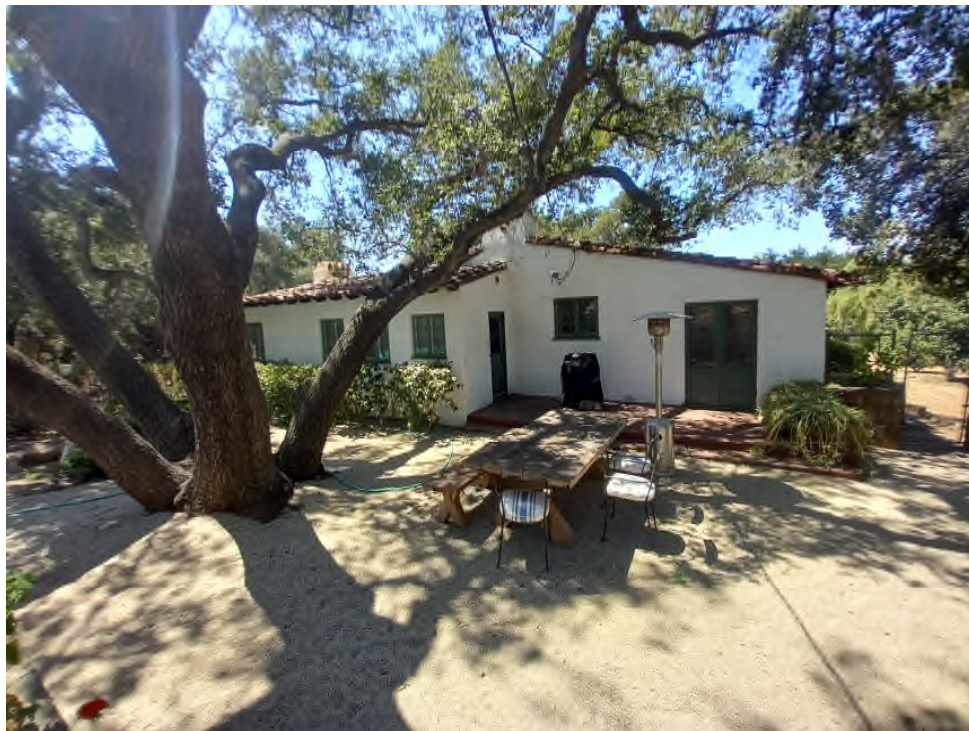
**Photograph #17 Property at 3935 Thacher Road
North end of east elevation (Looking west)**

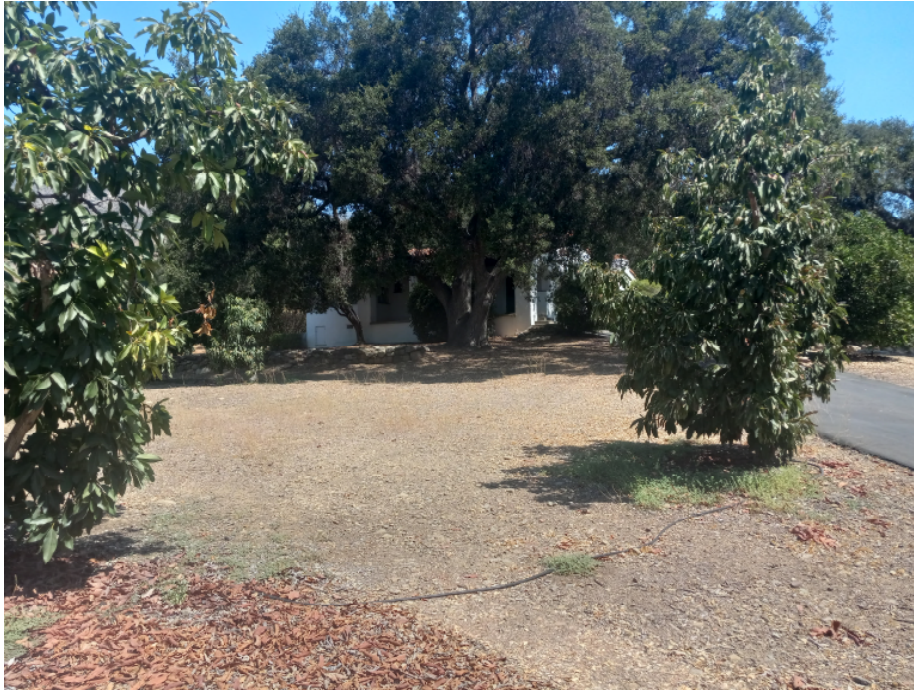
**Photograph #18 Property at 3935 Thacher Road
West elevation (Looking NE)**

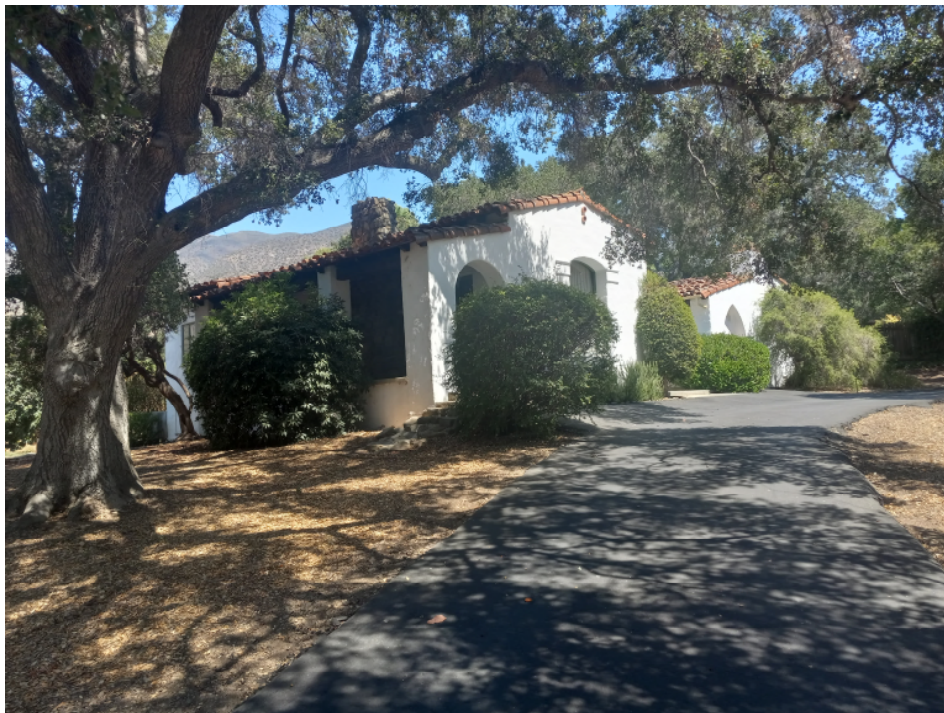
**Photograph #19 Property at 3935 Thacher Road
South end of west elevation (Looking NE)**

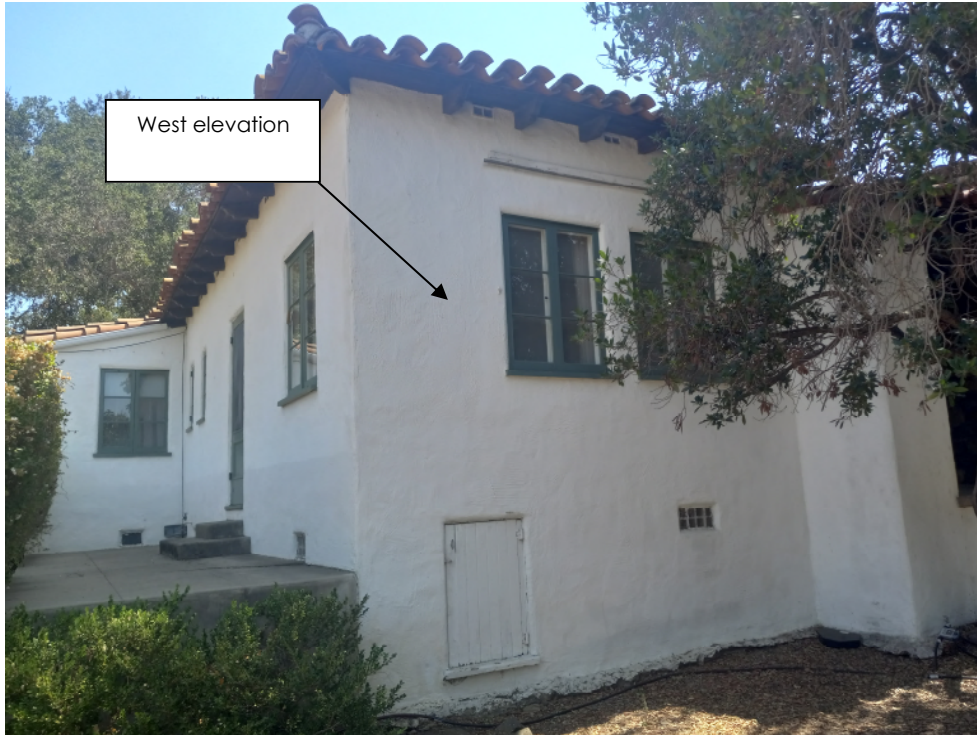
**Photograph #20 Property at 3935 Thacher Road
North end of west elevation (Looking SE)**

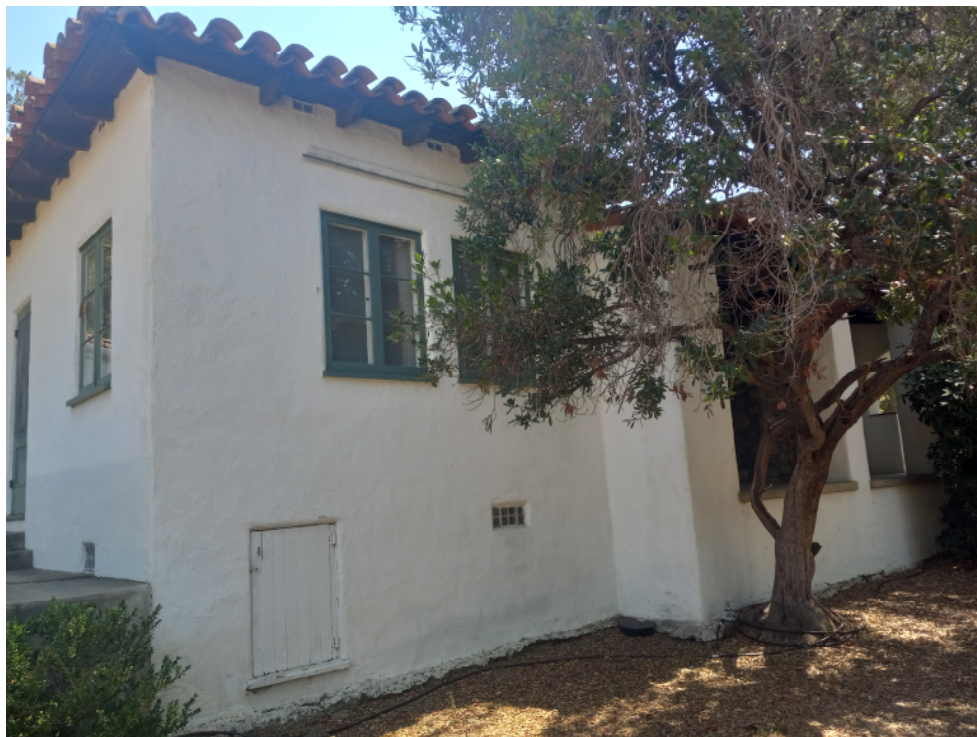
**Photograph #21 Property at 3935 Thacher Road
North end of west elevation (Looking SE)**

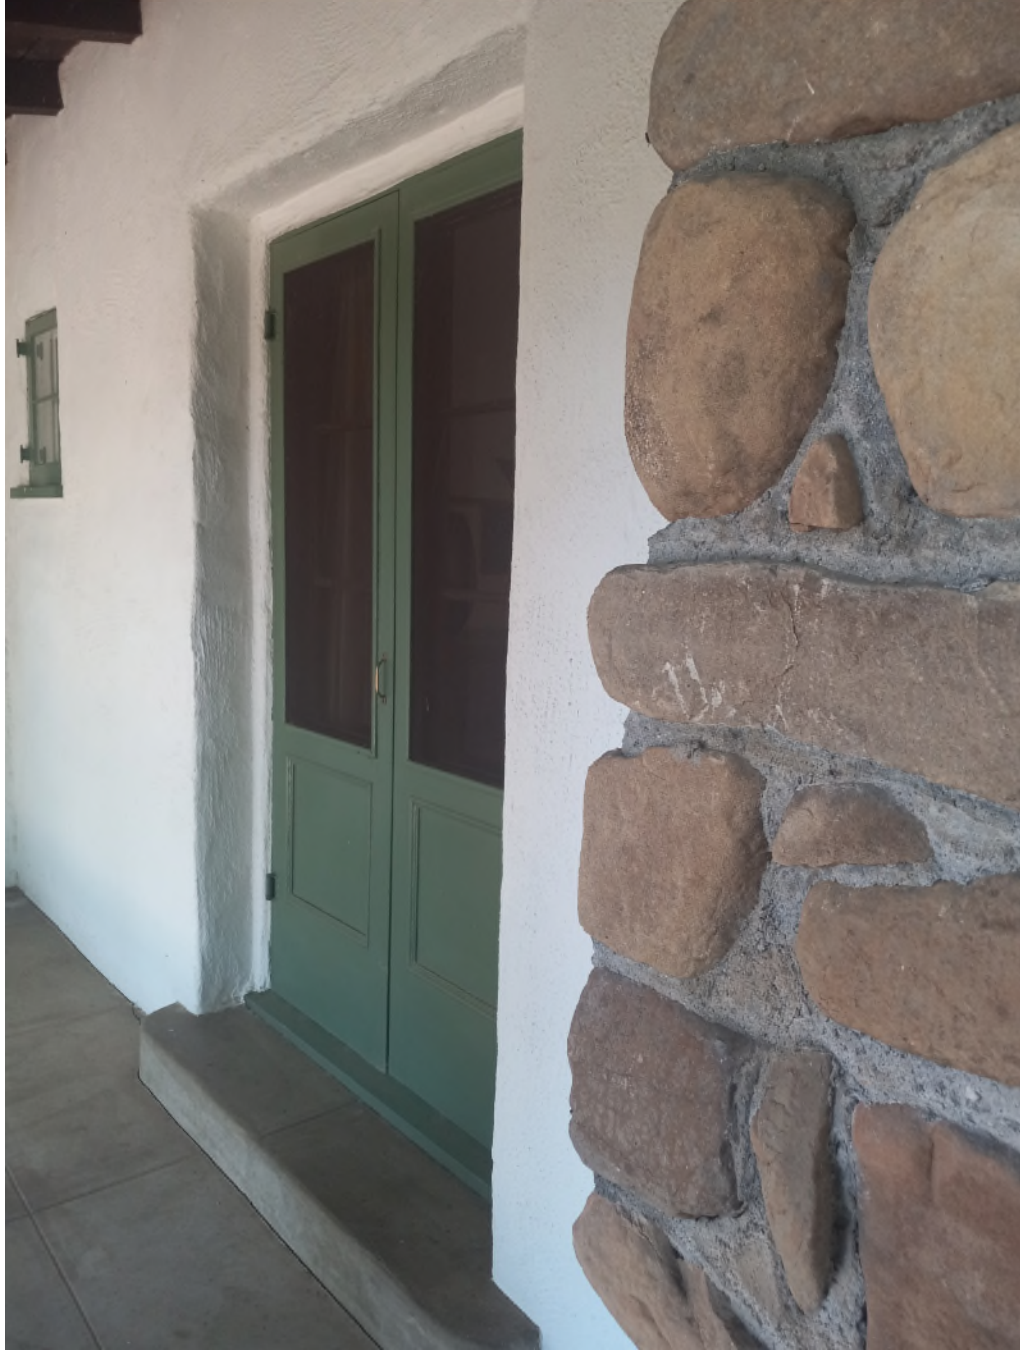
**Photograph #22 Property at 3935 Thacher Road
Detail of the porch on west elevation (Looking NE)**

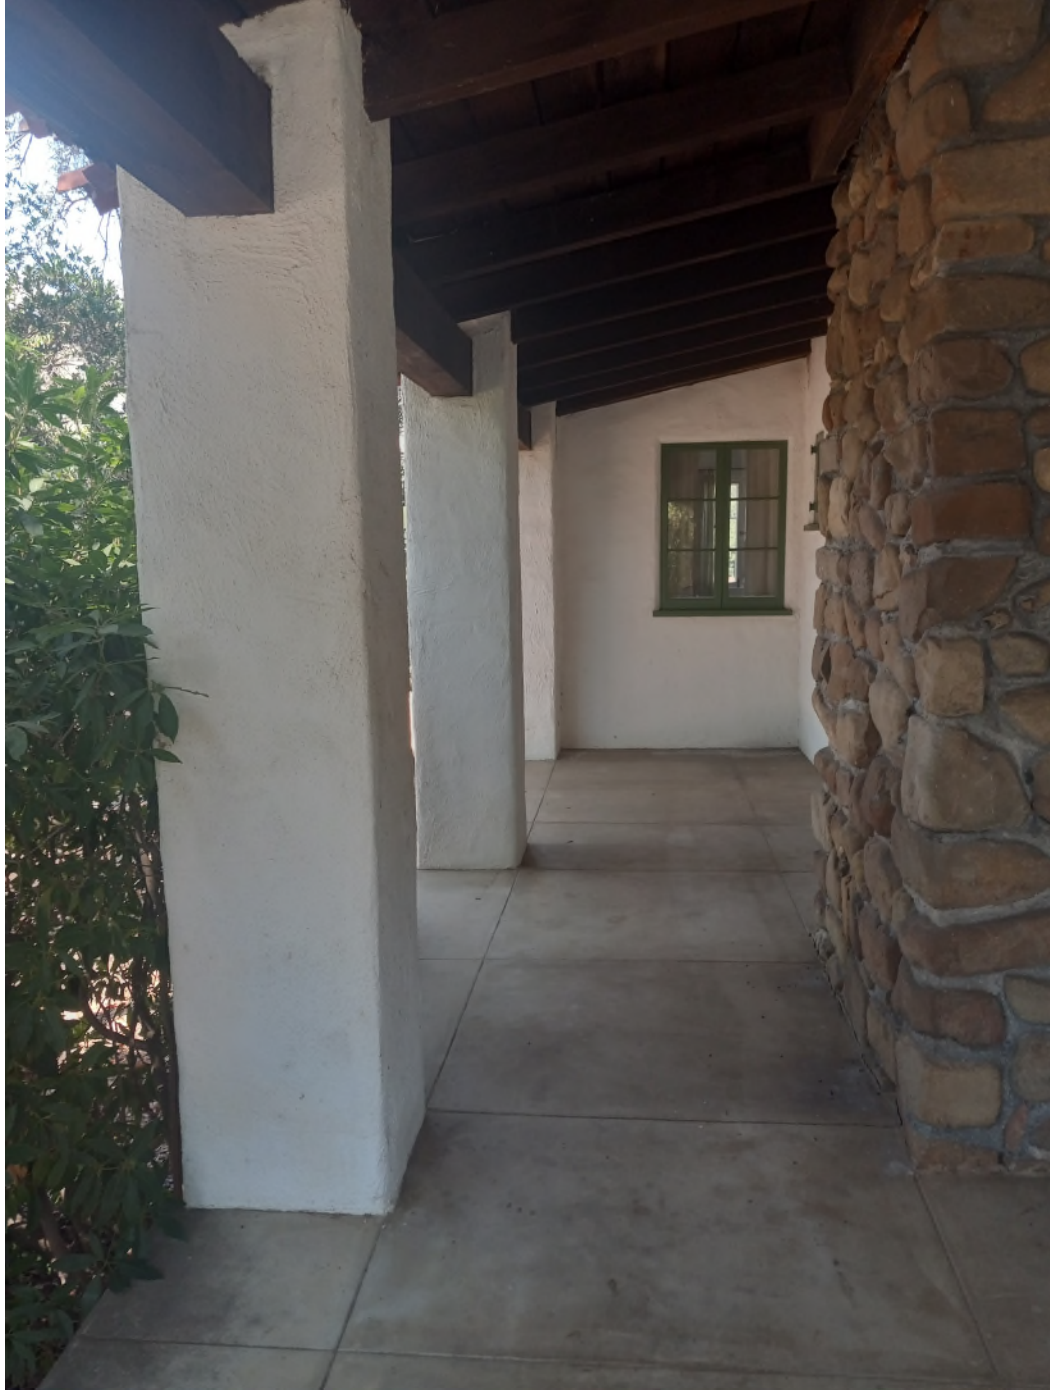
**Photograph #23 Property at 3935 Thacher Road
Detail of the porch on west elevation (Looking north)**

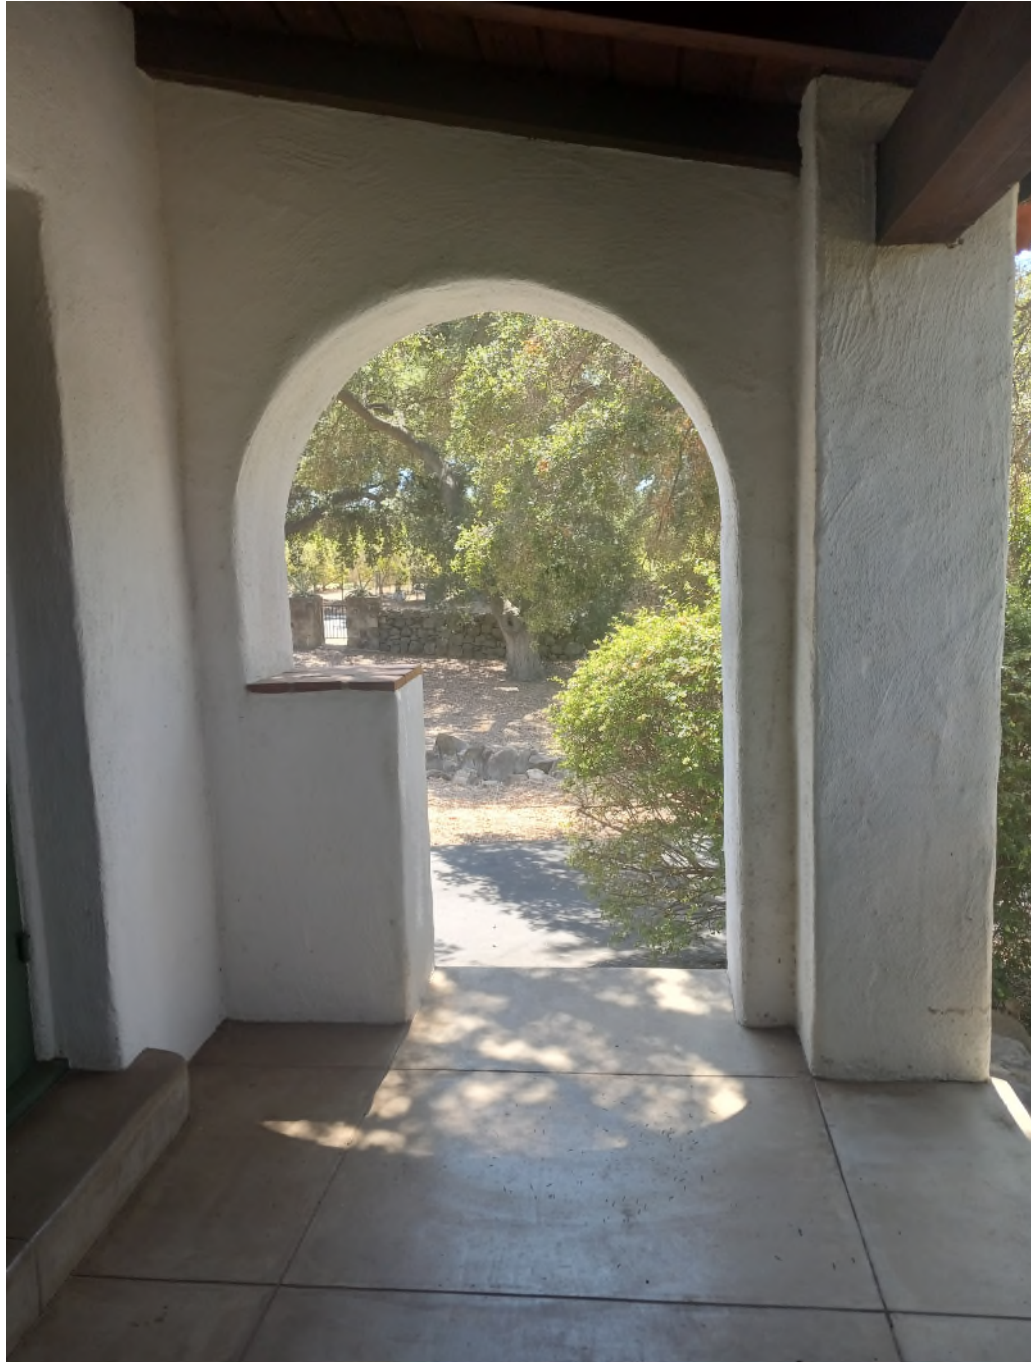
**Photograph #24 Property at 3935 Thacher Road
Detail of the front porch on the west elevation (Looking south)**

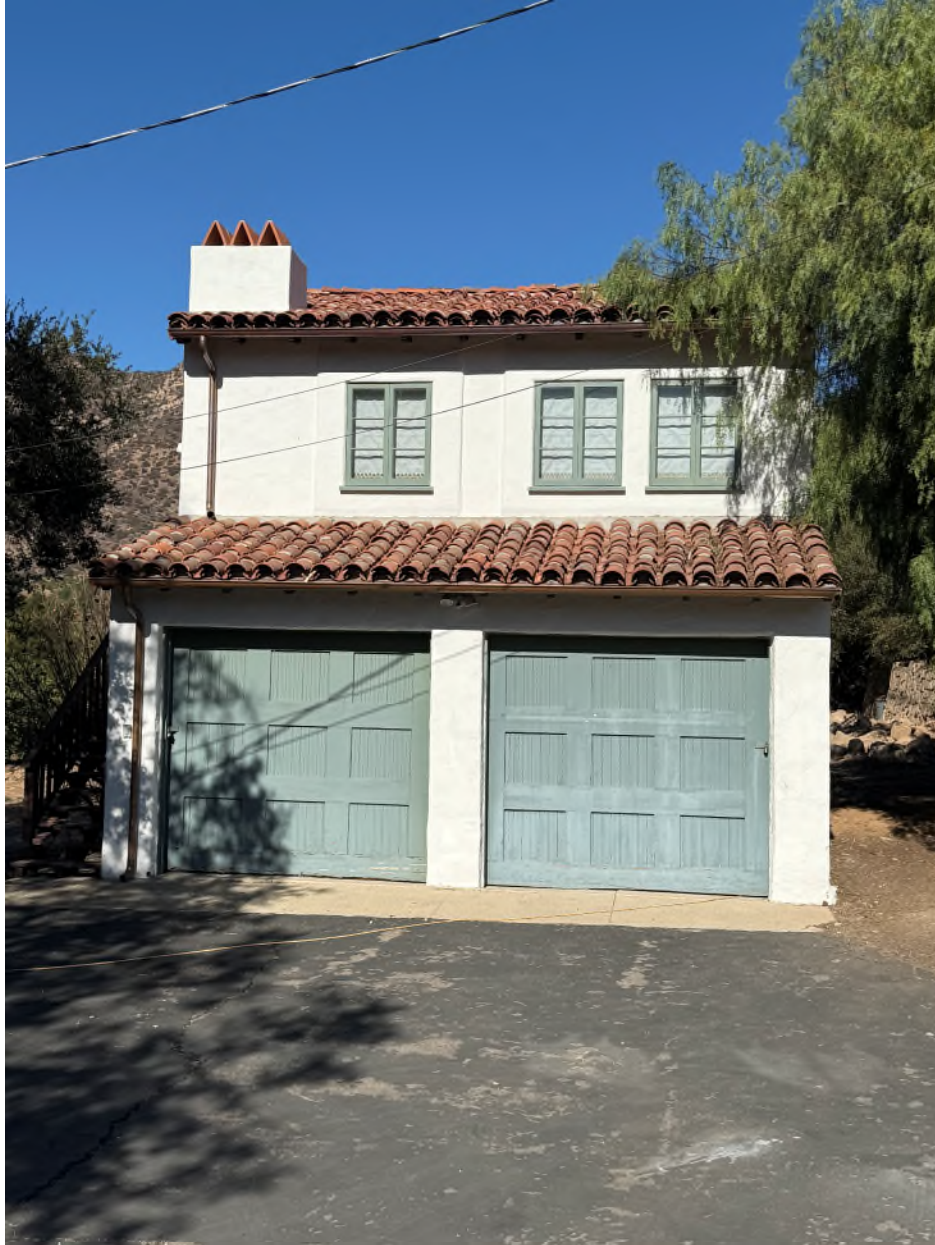
**Photograph #25 Property at 3935 Thacher Road
South elevation of the garage (Looking north)**

The south elevation, clad in stucco, is linear in configuration. The massing of the south elevation is broken into two components, an attached single-story, two-bay garage, and a recessed two-story living space to the rear of the garage. The single-story garage is dominated by two wood-paneled bay doors and is sheltered by a moderately-pitched shed roof covered in c-shaped terra cotta tiles; under its shallow eave are exposed rafter tails. Above and recessed to the rear of the garage component is a two-story living space. Fenestration on the second floor is comprised of a single, wood-framed multi-paned casement window toward the west end of the elevation and a pair of wood-framed multi-paned casement windows at the east end of the elevation. A truncated chimney projects from the east end of the two-story element; this chimney is identical in style to that of the house's chimney.

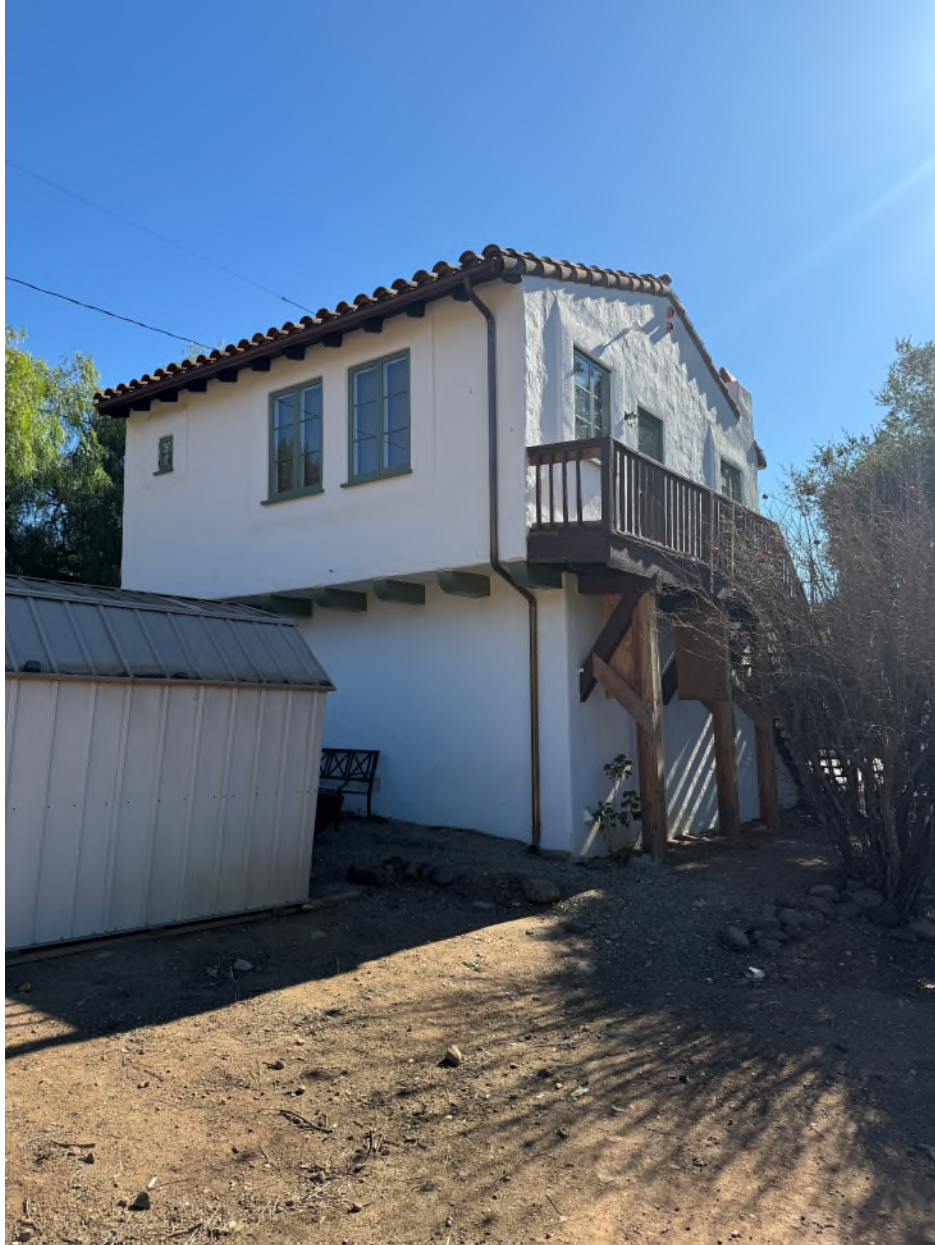
**Photograph #26 Property at 3935 Thacher Road
North elevation of the garage (Looking SE)**

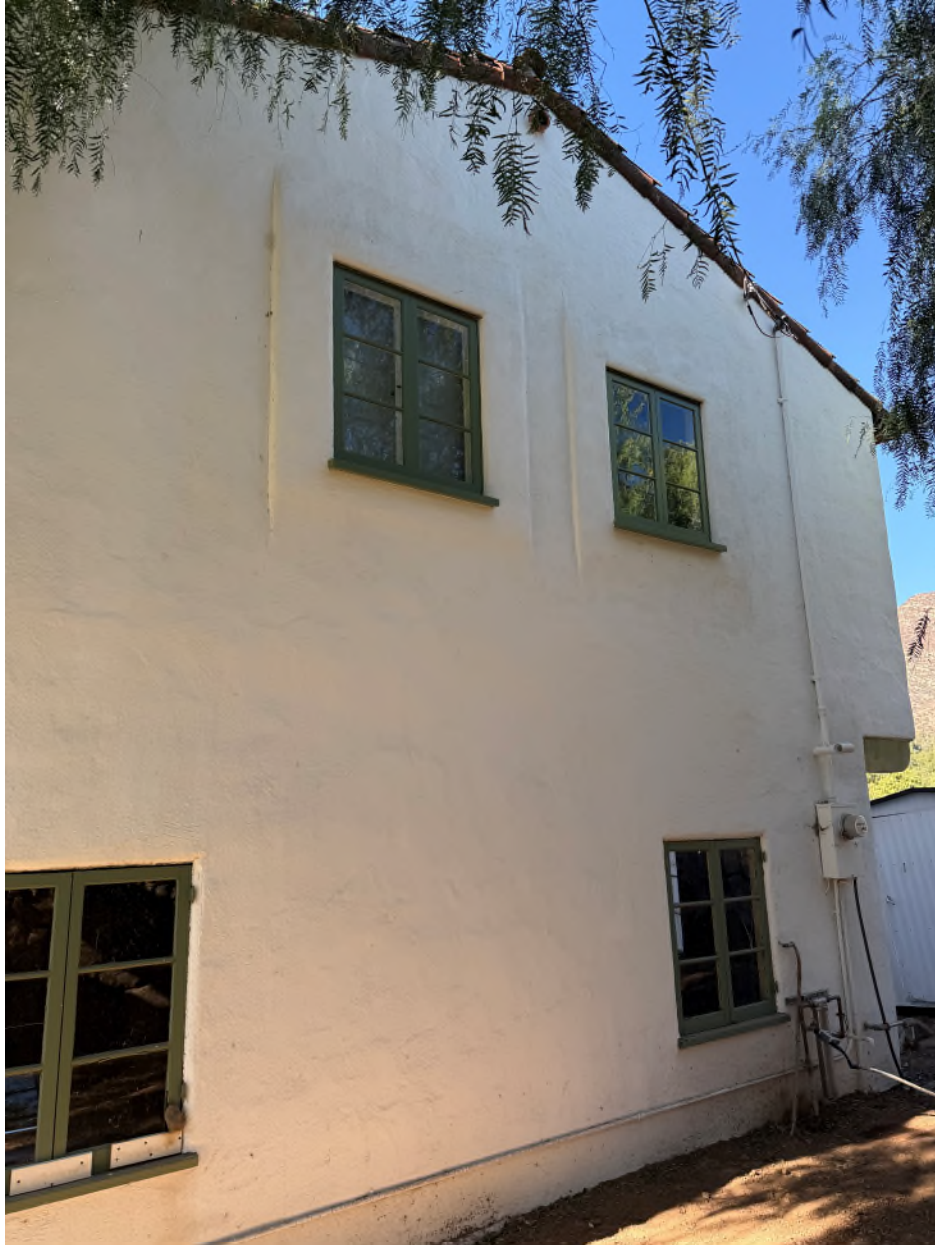
**Photograph #27 Property at 3935 Thacher Road
The south elevation of the garage (Looking north)**

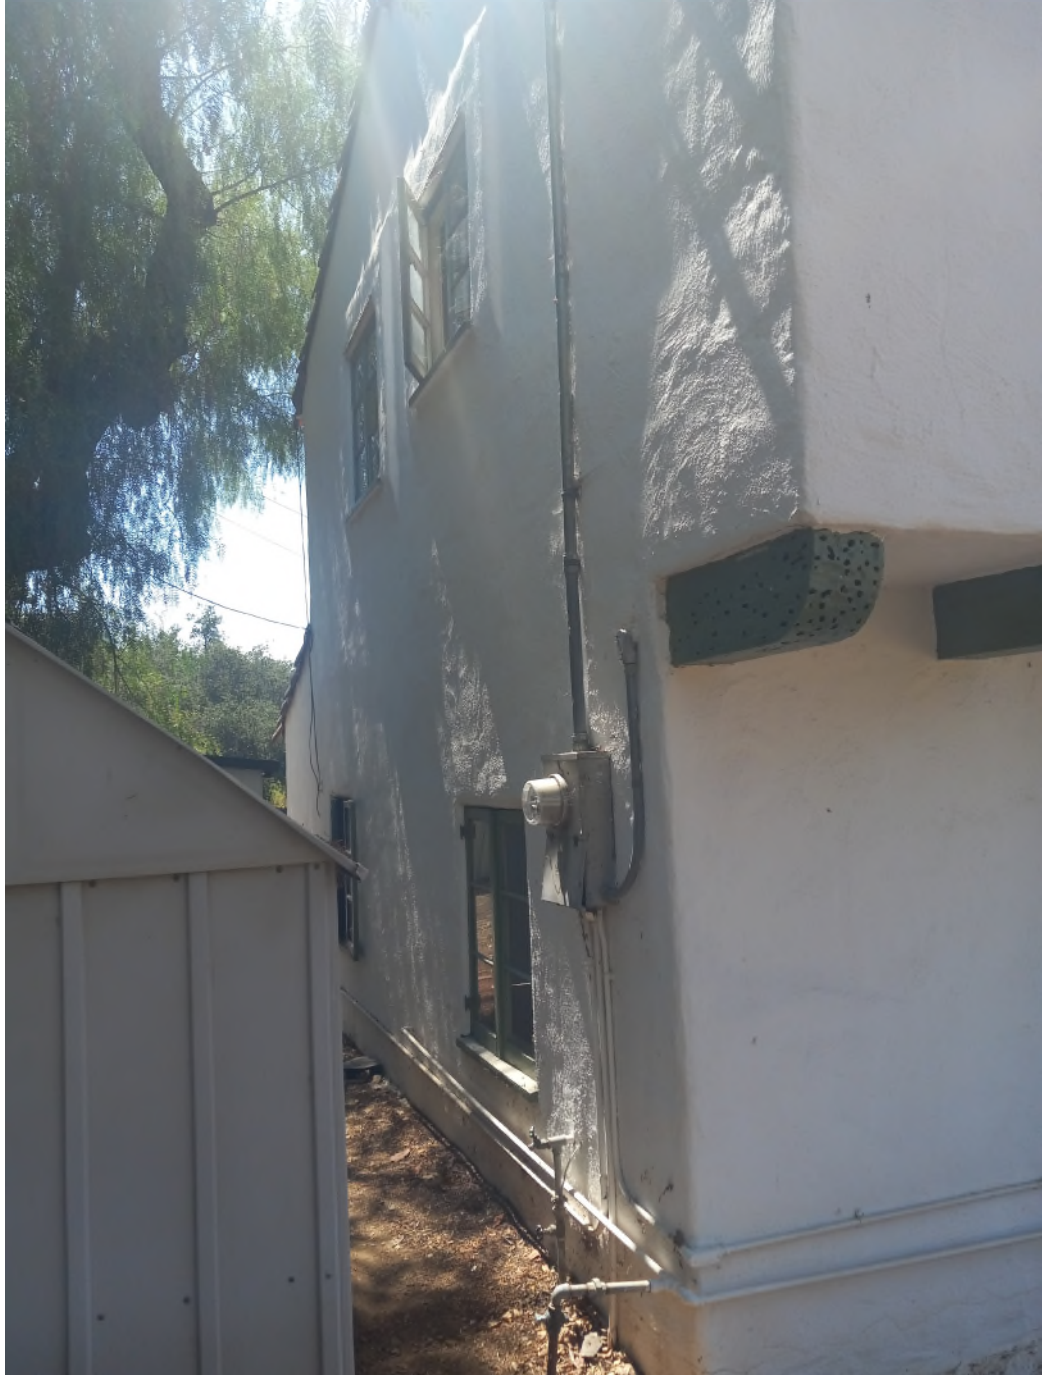
**Photograph #28 Property at 3935 Thacher Road
East elevation of the garage (Looking SW)**

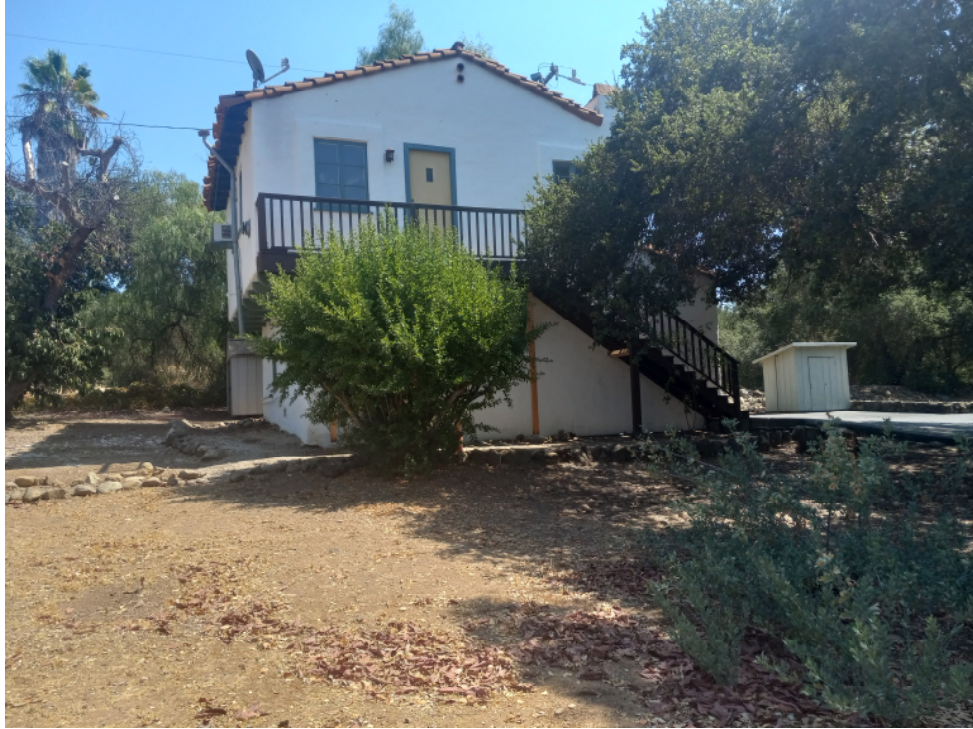
**Photograph #29 Property at 3935 Thacher Road
West elevation of the garage (Looking east)**

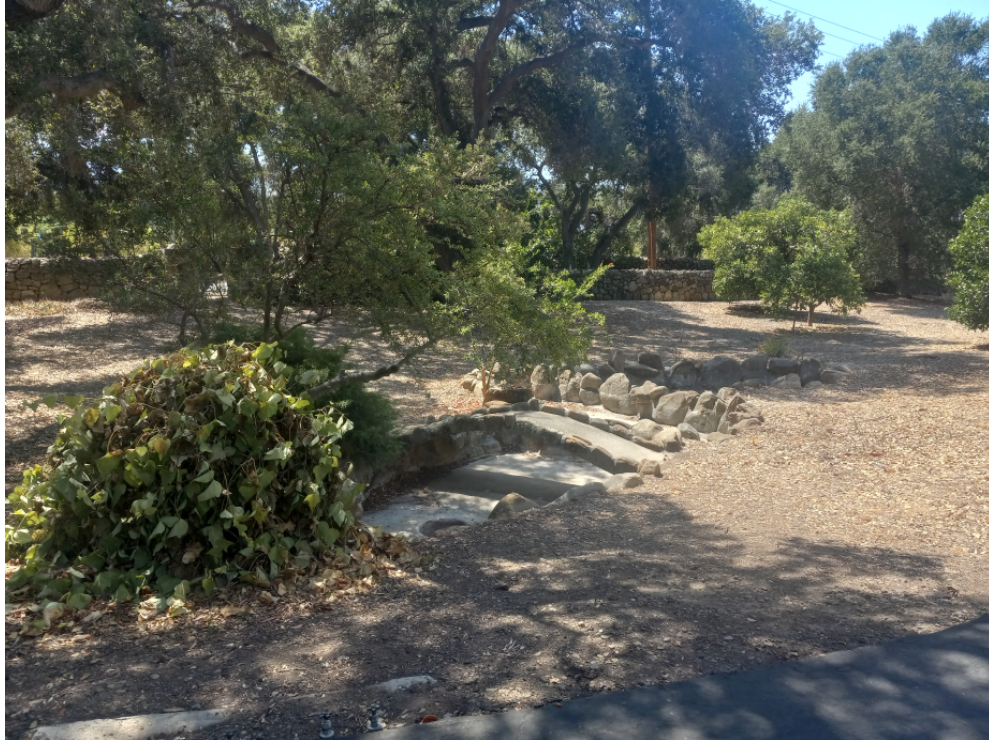
**Photograph #33 Property at 3935 Thacher Road
Water feature in the front garden (Looking SW)**

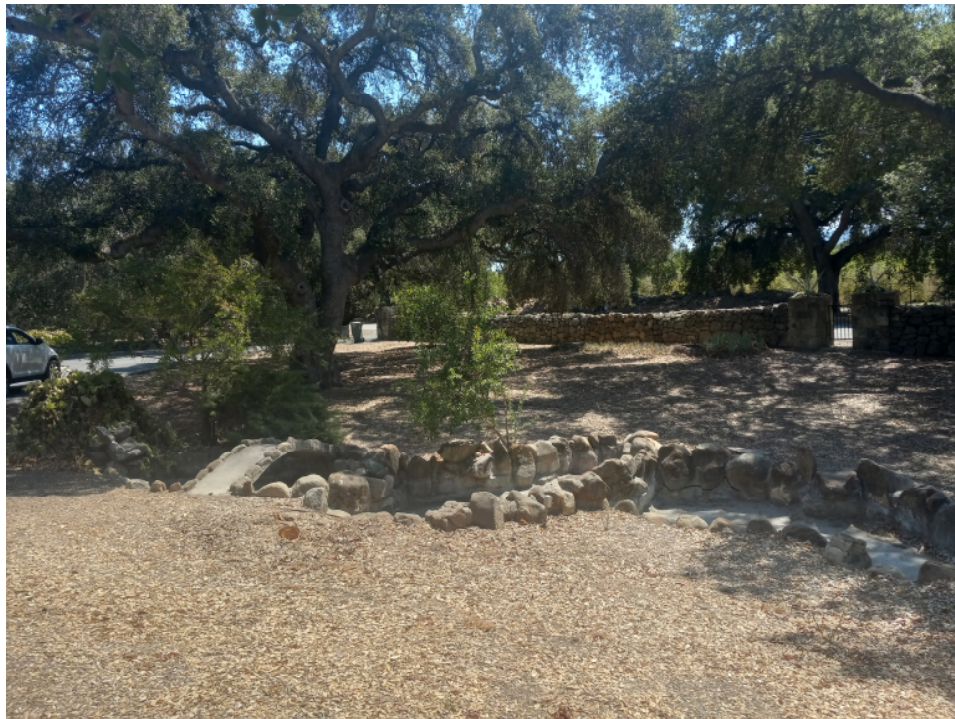
**Photograph #34 Property at 3935 Thacher Road
Water feature in the front garden (Looking SW)**
