Historic Resources Survey & Context

TOWN OF SATICOY

Ventura County, California

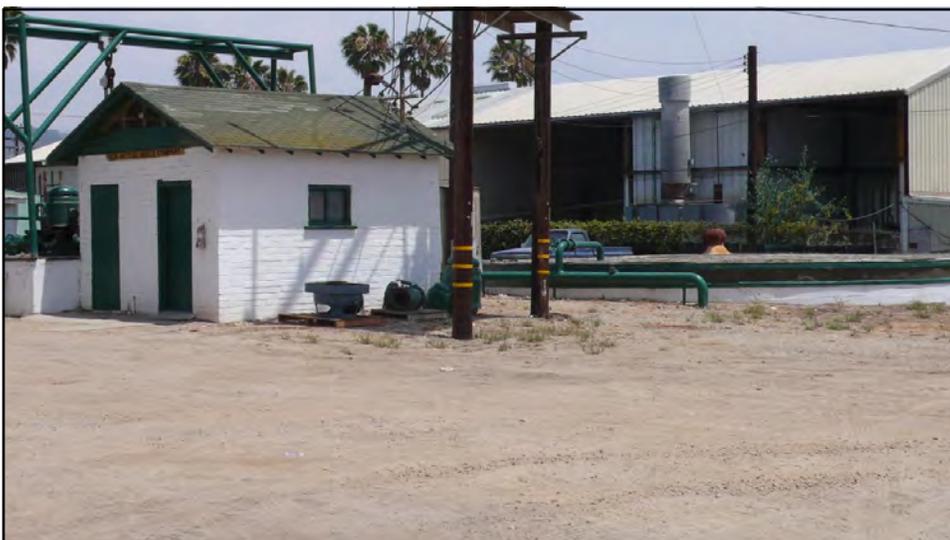
Description of Photo: (View, date, accession #)

Pumping Plant building. The date of construction is not known, but based on the method of construction it appears to be circa 1980. A number of other pipes, valves and other appurtenances of the water use are also seen on the property.

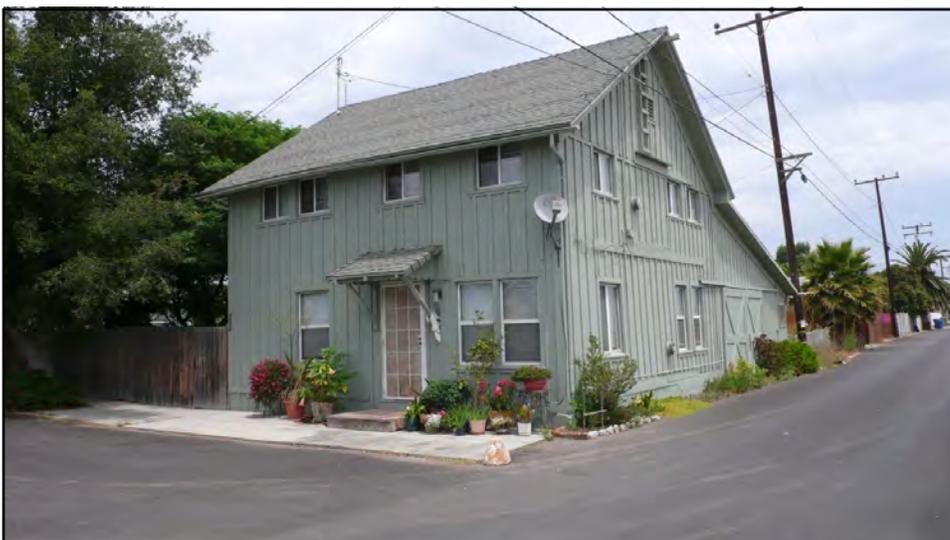
Description of Photo: (View, date, accession #)
Photo 04-29 (7-26-2013) (rear residence)

This one and two story building located at the rear of the parcel features a steeply-pitched side-facing gable roof with moderate, open eaves. A shed-roofed wing is attached to the eastern elevation. The building is clad in board and batten. An entry located on the center of the western elevation is covered with a small pent roof. Windows are sash on the ground floor in singles and in pairs, and smaller casement pairs on the second floor. These appear to be modern aluminum units in older window openings. A pair of overhead hung track doors are found on the southern elevation of the eastern wing, opening towards Rosal Lane. This building was apparently constructed as a stables and/or garage, along with the house, and converted to residential use at some point after 1929. Its integrity is difficult to assess, as no information was available to establish when it was altered for use as a residence. It is in generally good condition.

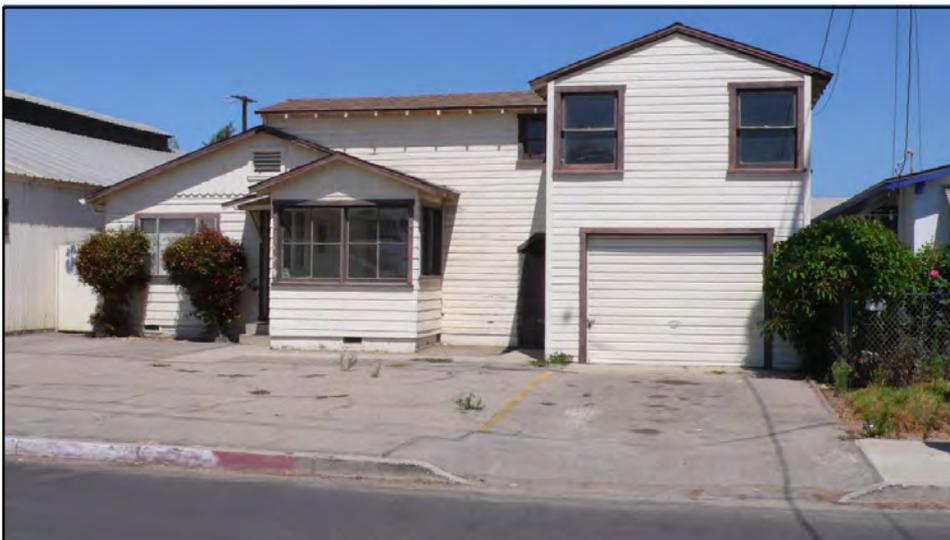
Description of Photo: (View, date, accession #)

The one and two-story residence is irregular in plan and was apparently constructed in at least two stages. The western, one-story section features a main front-facing, medium-pitched gable roof with moderately deep, open eaves, and a secondary gable roof to the east enclosing a porch with large, wood framed windows. Vertical drapery moldings are found under the gable ends. This wing is clad in wide lap siding. The two-story eastern wing is clad in medium lap siding and consists of a front-facing medium-pitched gable with very shallow eaves, and a pair of wood sash windows on the second floor above a single-car garage door. A side-facing gabled two-story wing connecting the eastern and the western wings is nearly featureless except for a small sash window and a gated passage on the ground level. It appears that this building is the combination of one if not two residences that existed on the property prior to its purchase by Brigham Manufacturing in 1937. The integrity of the building, which according to Brigham family members was also used as an office, is intact from circa 1937.
